**NEWER LUXURY HOMES WITH STUCCO EXPERIENCING STRUCTURAL DAMAGE**  
*Philadelphia-area Builder Sees Rainscreen Wall Construction as Solution*

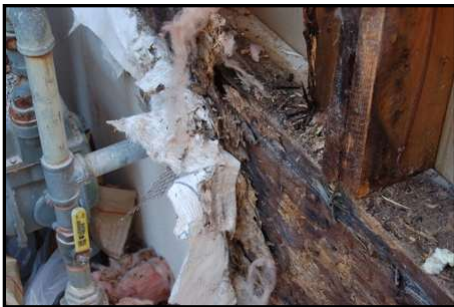
### **CAPTION #1**

When Haller Custom Homes removed the exterior stucco cladding of one home in the Philadelphia suburbs, the vast amount of structural damage and rot behind the cladding was revealed.
